DOT/FAA/RD-93/23

Performance of Prefabricated Geocomposite Subdrainage System in an Airport Runway

Final Report

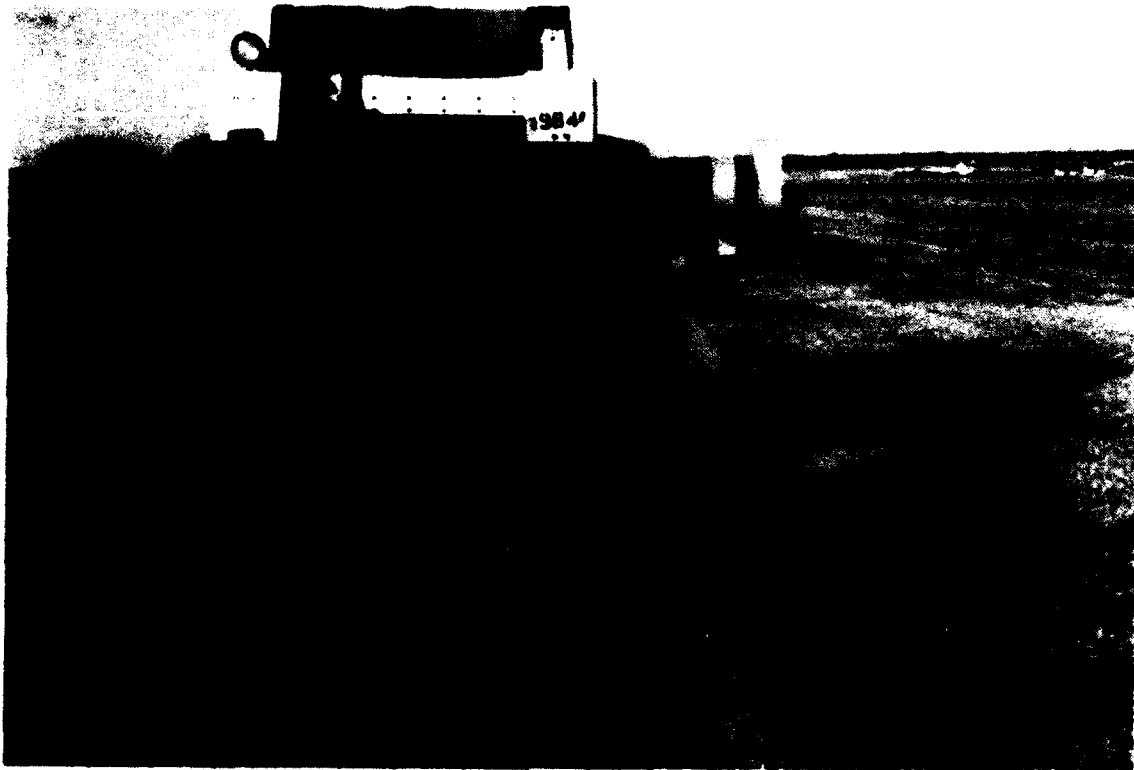
Figure 14. Tractor Mounted PGS Material Installation and Backfill Equipment.

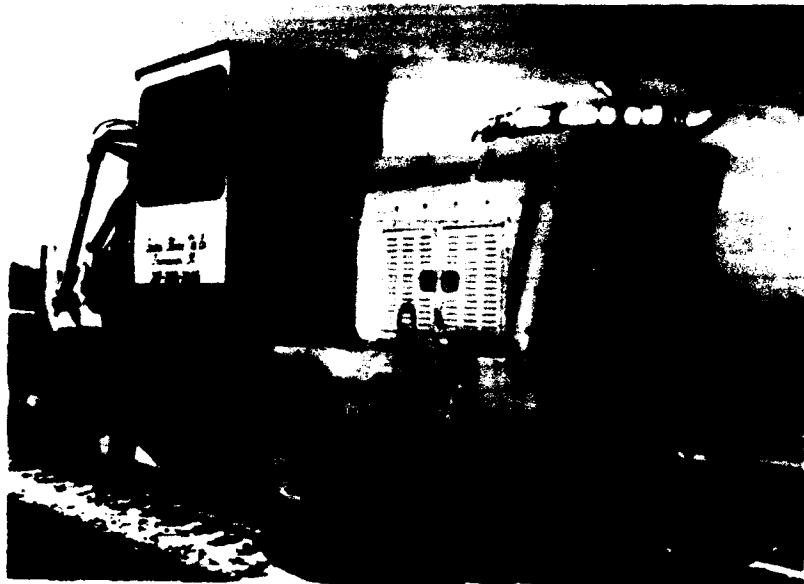
Figure 15. High Speed Wheel Trencher Installing PGS Material.

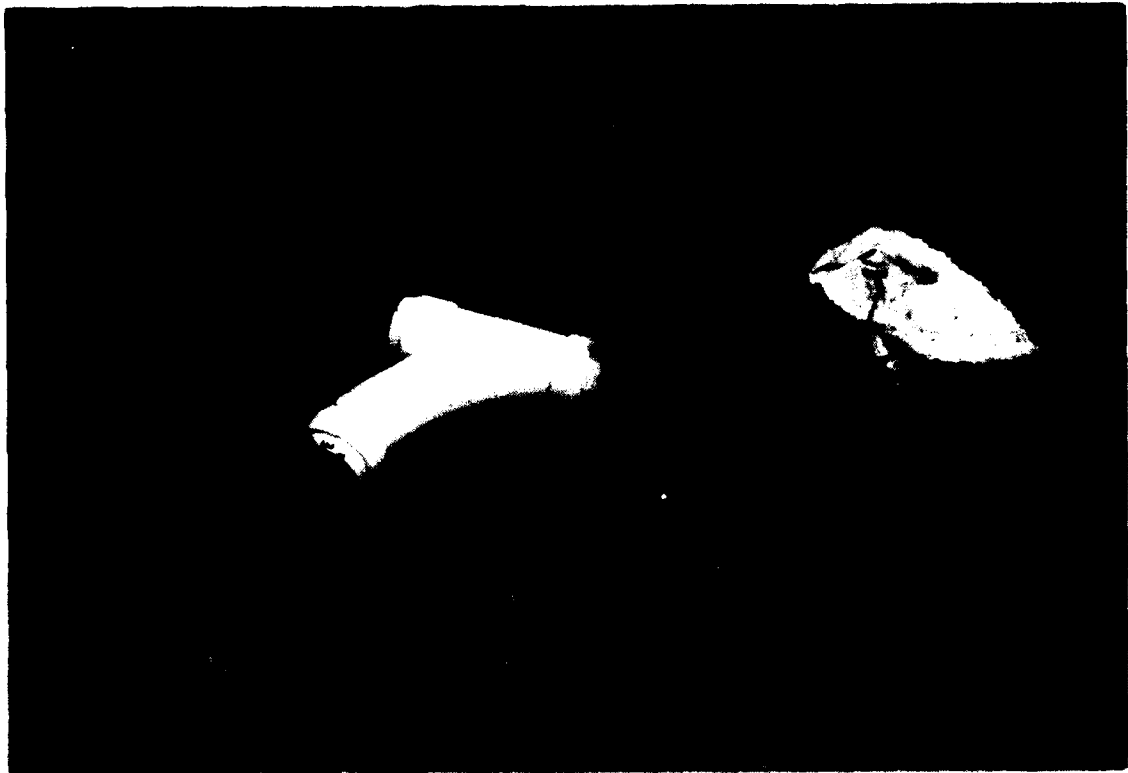
Figure 17. Method for Connecting Several PGS Systems Together.

Figures 17 and 18 show a method of using standard outlet fittings for interconnecting several GPS sections. It is important during construction to use the proper Tee outlets, end outlets, and end caps to insure that soils and materials cannot infiltrate through a hole into the GPS core. In most cases the Tee outlet and end outlet fittings are attached to a circular pipe which then carries water to a ditch or to a storm drain.

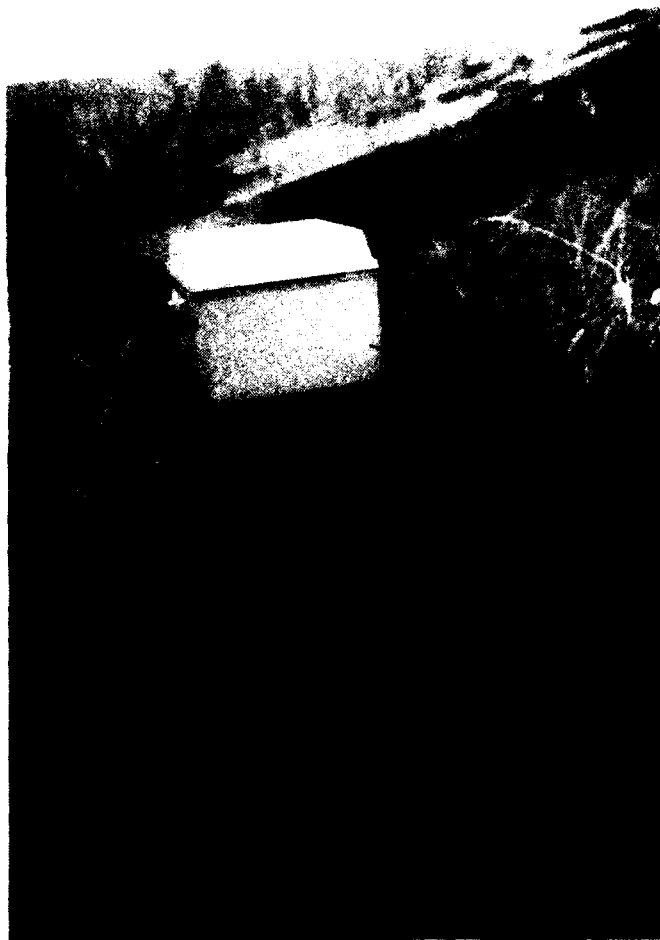
Figure 19. Outflow Metering Flume and Data Logger at Kewanee Municipal Airport.

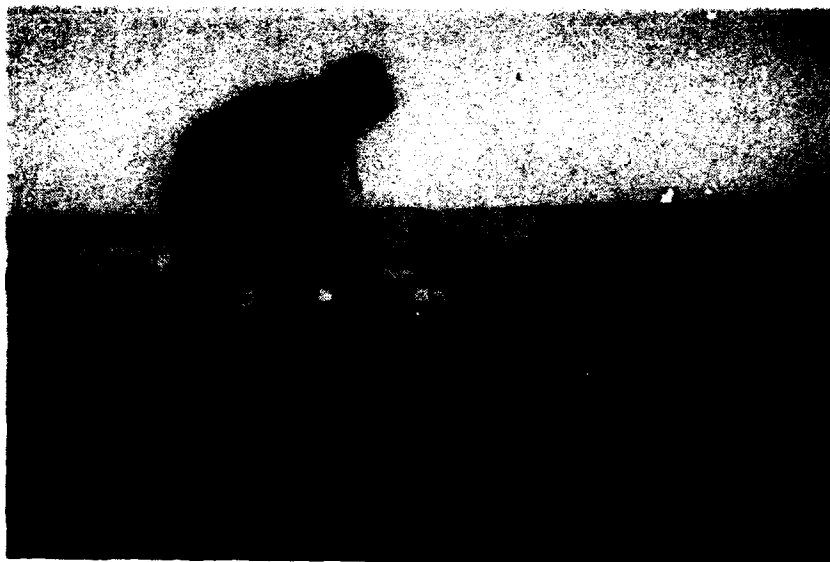
Figure 29. Asphalt Concrete Plug Located Over
the PGS System in Runway 09-27.

asphalt concrete plug placed back into the 4 in. wide cut made to install the PGS system 12.5 ft on either side of the runway centerline. Figures 28 and 29 show the good condition of the asphalt concrete plug approximately three years after installation of the PGS system. It was felt that the in-runway installation of the PGS system did not create any safety hazards to aircraft operating on the runway pavement.
